Field Survey of the 2018 Sulawesi Tsunami: Inundation and Run-up Heights and Damage to Coastal Communities

Abstract—On September 28, 2018, a large earthquake and its accompanying tsunami waves caused severe damage to the coastal area of Palu Bay, in the central western part of Sulawesi Island, Indonesia. To clarify the distribution of tsunami inundation and run-up heights, and damage to coastal communities due to the tsunami, the authors conducted a field survey 1 month after the event. In the inner part of Palu Bay tsunami inundation and run-up heights of more than 4 m were measured at many locations, and severe damage by the tsunami to coastal low-lying settlements was observed. In the areas to the north of the bay and around its entrance the tsunami inundation and run-up heights were lower than in the inner part of the bay. The tsunami inundation distance depended on the topographical features of coastal areas. The southern shore of the bay experienced a longer inundation distance than other shores, though generally severe damage to houses was limited to within around 200 m from the shoreline. The main lessons that can be learnt from the present event are also discussed.

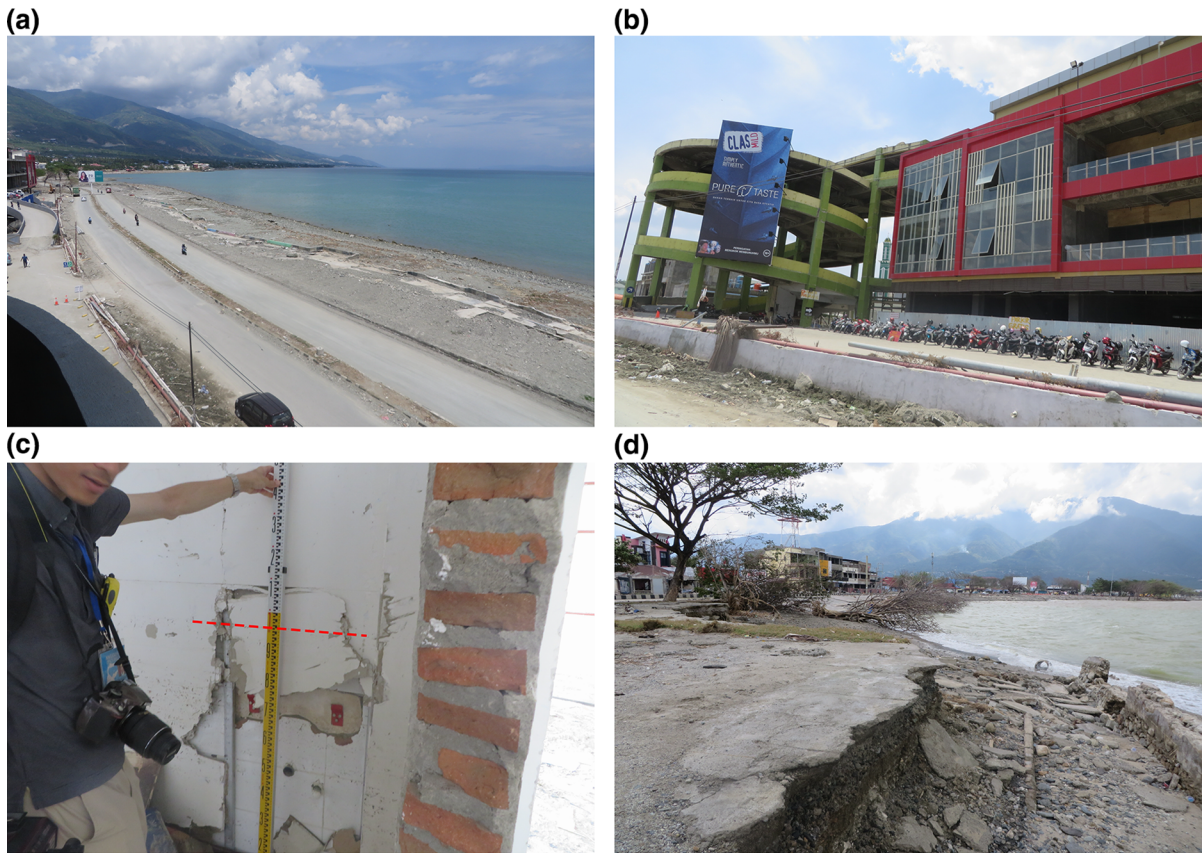
Figure 3

In Taman Ria a coastal road suffered severe damage, probably due to both the earthquake and tsunami. All of the houses, cafes and shops that were located seaward from the road were washed away due to the tsunami flow (see Fig. 3a). The measured inundation height in this area was 5.2 m. A multi-story shopping mall and parking garage are located about 500 m east of the point where the inundation height was measured. These structures served as a vertical evacuation destination for many people during the event. A spiral ramp providing vehicle access to the upper levels of the parking garage (see Fig. 3b) helped people to climb easily to the higher levels (a video posted by Channel NewsAsia (2018)

The campus of IAIN Palu is located just east of the aforementioned shopping mall. In the campus there were several two-story buildings, with the tsunami causing severe damage to the first floor. Inundation heights of 1.8 and 3.0 m were measured at two of these buildings, which were located 100 m and 200 m from the shoreline, respectively. It should be noted that since the inundation height was measured according to mudlines found inside the buildings (see Fig. 3c), the maximum water level outside might have been higher. The flow depth at the latter building (200 m from the shoreline) was 1.61 m, indicating how the tsunami at this point had enough energy to reach further inland.

the bay, probably by a combination of return flows and localized land subsidence (possibly indirectly caused by submarine landslides and/or liquefaction) at the coast (see Fig. 3d). Several broken trees were also found near the coast. They were folded toward the west, suggesting that there was a strong tsunami flow from east to west (which corroborates witnesses' reports of the direction of the incoming wave). A 2.7 m inundation height was measured at a tree in this park. It is important to note that the ground level at the location of this tree was 1.0 m above sea level at the time of the survey, but this level is 0.5 m below the estimated tidal level at the time of tsunami arrival, providing further evidence that localized land subsidence took place in this area. Another example of a part of the coastline that collapsed into the water was found about 1 km northeast from the park, where an inundation height of 3.3 m was measured.

Tsunami survey in the south area: **a** coastal area of Taman Ria, **b** spiral ramp at a shopping mall in Taman Ria, **c** mudline found inside a building on the campus of IAIN Palu, **d** part of the coast that collapsed into the water at Talise

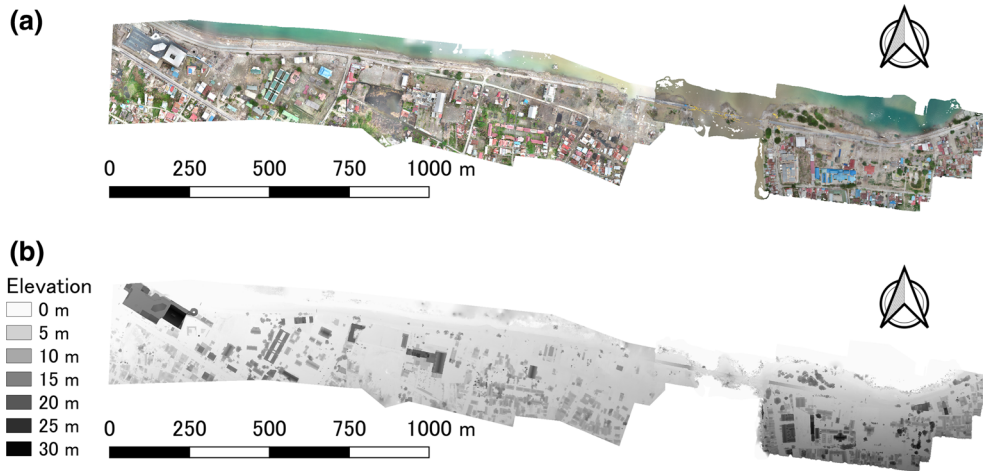
In some parts of the south area an aerial photographic survey was conducted, as mentioned earlier. Figure 4 shows the aerial image and DEM obtained from this survey. After analyzing the results, it would appear that the most severe damage was concentrated within 100–200 m from the shoreline, with hardly any structural damage observed after 200 m (it should be noted that in the most severely inundated areas some buildings had already been removed by cleaning efforts before the survey began, so it was

difficult to fully corroborate this observation). Considering the relatively flat ground elevation in this area, the rapid decrease in the degree of damage with distance indicates that the wavelength of the tsunami generated in Palu Bay was probably not as large as that of events generated by co-seismic vertical deformation.

Figure 4
Results of an aerial photographic survey of the south area: **a** aerial image, **b** digital elevation model (DEM)

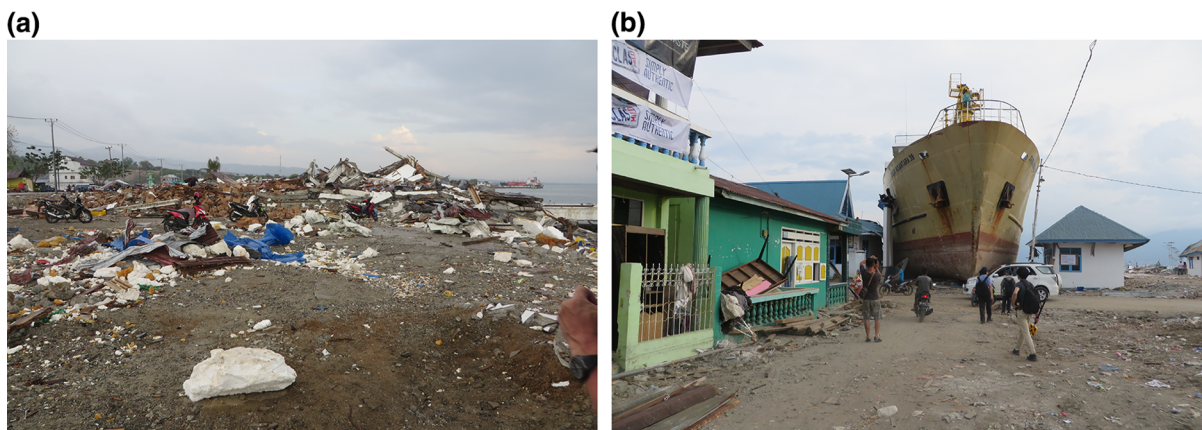
In Mamboro, severe damage was observed to structures in the low-lying coastal ground (within 50-150 m from the shoreline). Almost all houses and trees located seaward from the main road were washed away (see Fig. 6a). Inundation heights at two different houses in Mamboro were measured to be 4.7 m and 5.1 m. Both of the houses were located landward from the main road, and damage was rather limited (though some walls and fences were damaged) compared to houses located on the seaward

Figure 6
Tsunami survey in the east area: **a** tsunami damage in Mamboro, **b** grounded ship in Wani2

Wani2 has a small port, and several ships that were docked there were left stranded on the ground close to the pier (see Fig. 6b). A house located around 80 m from the quay of the port was surveyed, and the inundation height according to a mudline left on a window on the first floor was 1.7 m. The residents of this house mentioned that the highest water level they had observed had been higher than that mudline, though lower than the second floor of the house (the level of the second floor was 1.5 m higher than the level of the mudline). This indicates that the maximum inundation height at this house was between 1.7 m and 3.2 m. According to residents, the tsunami arrived 4 min after the earthquake.

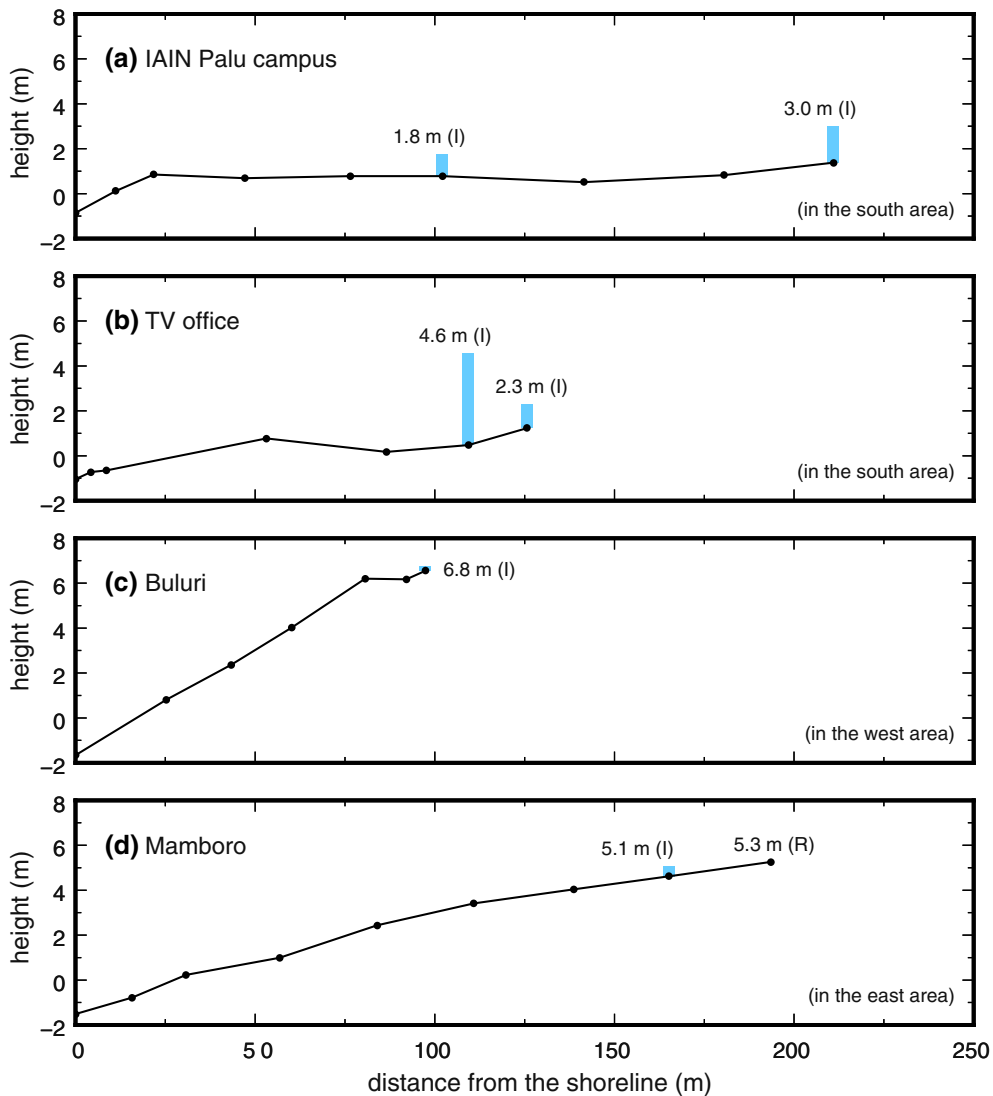
The tsunami inundation distance from the shoreline varied according to location. Figure 7 shows the profiles of the measured tsunami inundation and run-up heights and ground levels at four different locations. In the west area, as the mountains are located close to the coast, the inundation distance was around 100 m. In the east area the tsunami could travel further inland, as the slope is much milder than in the west area. On the other hand, in the south, which has a wide low-lying coastal plane, the tsunami reached more than 200 m from the shoreline at some locations. The results of an aerial photographic survey using a UAV clearly show that the tsunami reached further inland in this area, compared to the other areas surveyed. However, even in the south area

Profiles of measured tsunami inundation and run-up heights and ground levels at the time of the arrival of the tsunami: **a** IAIN Palu campus, **b** TV office, Palu, **c** Buluri, Palu, **d** Mamboro, Palu

the inundation distance did not go as far as the authors would have expected and severe damage to houses was found within around 200 m from the shoreline. For example, in the case of the 2010 Mentawai Islands Tsunami, in which the measured tsunami inundation and run-up heights were similar to those in the 2018 Sulawesi event, the inundation distance was longer than 400 m at some of the affected locations (Hill et al. 2012; Satake et al. 2013; Mikami et al. 2014). Although the topographical features varied from place to place (as shown in Fig. 7), overall the damage due to the tsunami in the
